Coal Mine Fatal Accident 2003-18

Operator:	Solar Sources Inc.
Mine:	Craney Mine
Accident Date:	June, 23, 2003
Classification:	Machinery
Location:	District 8, Vincennes, Indiana
Mine Type:	Surface
Employment:	110
Production	3,700 tons/day

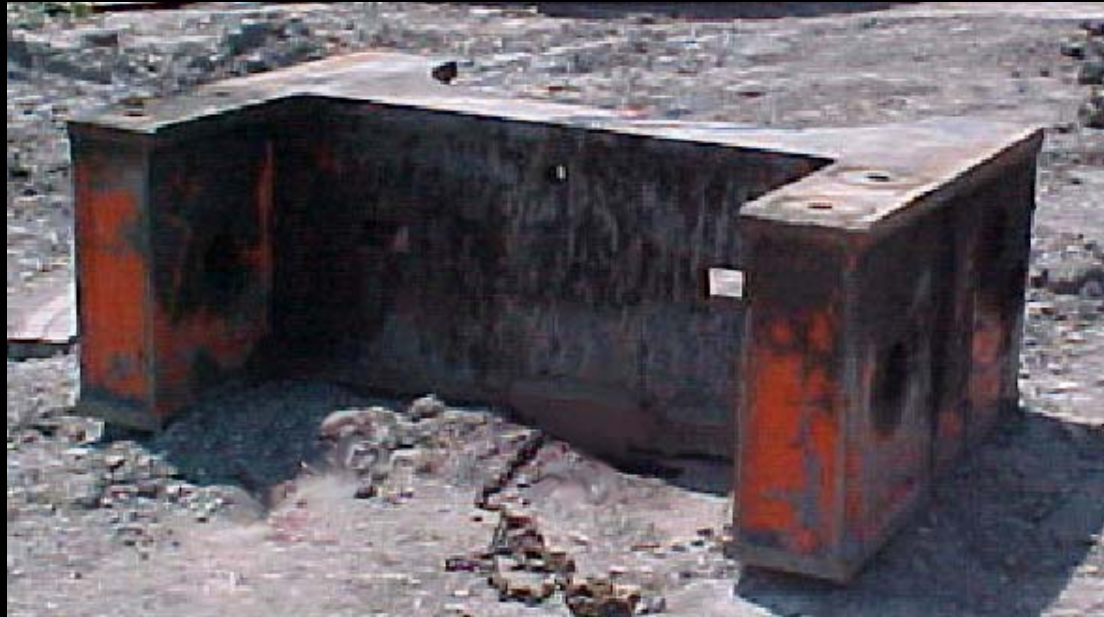
- On June 23, 2003, a 47-year old mechanic with 27 years of mining experience was fatally injured at a surface mine repair yard while preparing to move a section of an excavator mainframe with a front-end loader.
- The mainframe was to be used to block up another piece of equipment that was going to be repaired.

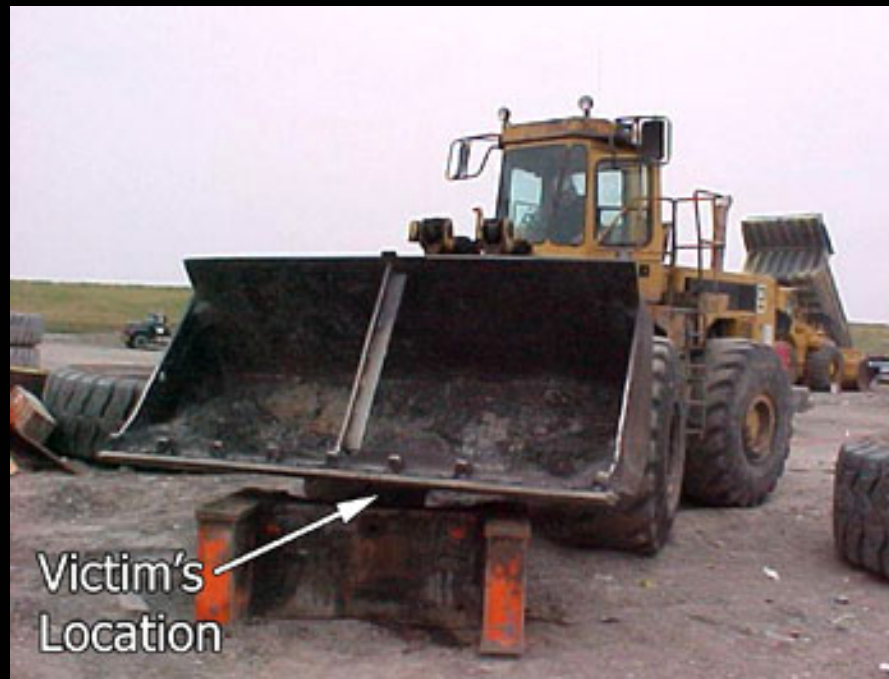
- After the front-end loader operator positioned the loader bucket over the mainframe section, the victim reached under the bucket to attach a chain between the mainframe section and the bucket.
- During the process, the loader bucket drifted downward, pinning the victim's head between the mainframe and the bucket.

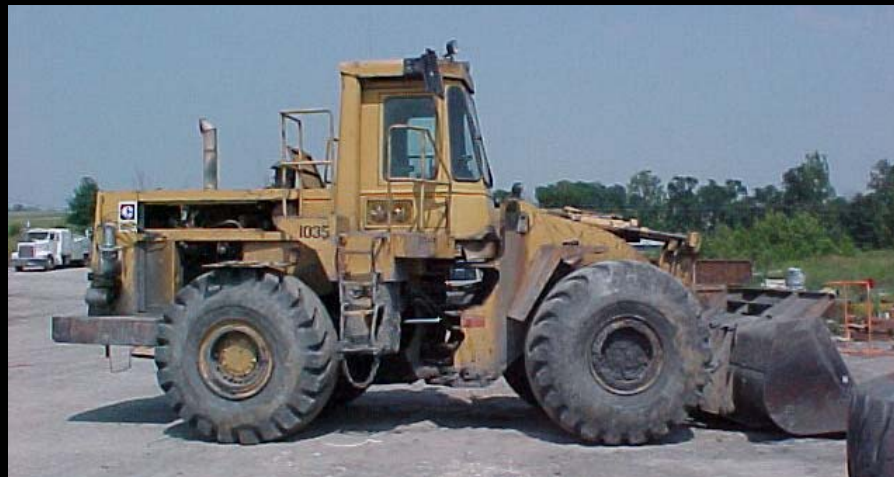
- The victim was at a surface repair yard preparing to work on a 988-F Caterpillar front-end loader, which was being torn down to be bushed and pinned.
- During lunch, he ask another mechanic to help him split the 988-F front end-loader so he could continue work on the machine.
- They decided to use the 980-C front end-loader to move material needed to block the 988-F loader prior to separating it.
- A smaller front end-loader equipped with forks was normally used for this task, but was being used by the pumper at that time.

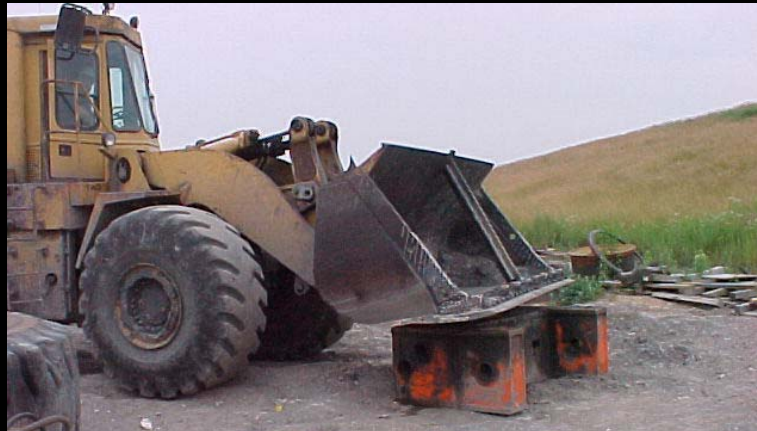
- After positioning the bucket, the mechanic applied the loader parking brake.
- At this point, victim was going to hook the metal block to the front-end loader bucket with a chain.
- During this time, the victim disappeared from the equipment operator's field of vision, where he remained unseen for several minutes.
- The equipment operator walked toward the bucket to see what was taking so long and found the victim with his head pinned between the metal block and the bucket.

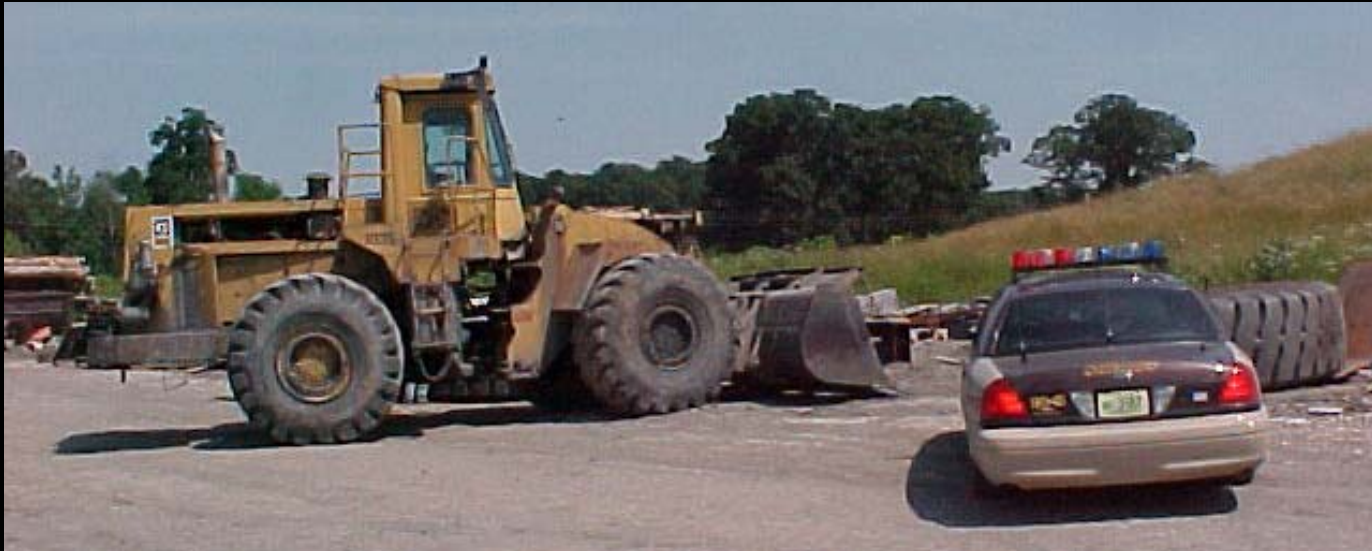
- The front-end loader operator rushed back to his cab and raised the bucket.
- He then checked the victim for a pulse and found none.
- Help was summoned and 911 called.
- The victim was later pronounced dead by the county deputy.
